WORKHORSE CUSTOM CHASSIS SERVICE BULLETIN

BULLETIN NO: 51101-C

SUBJECT: Replacement of Bosch Service Brake Calipers

MODELS: All 2001 through 2011 Model Year W20, W21, W22, and W22D Motor Home Chassis Equipped with Bosch Brake Calipers

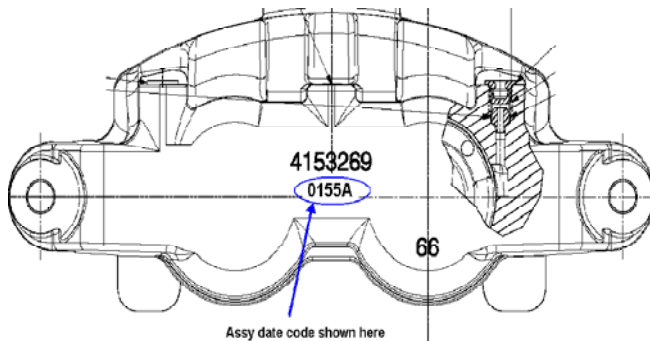
Part Number W8006753 (Caliper Kit)

Remedy Bosch Brake Caliper Identification

The first date code was 0155A.

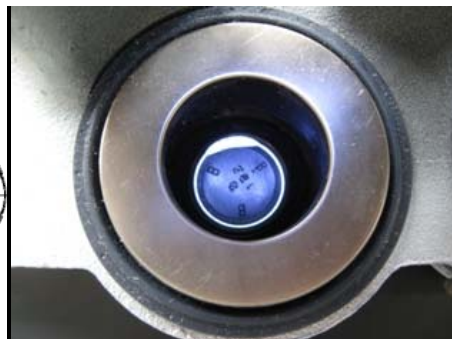
The pistons have the letter "B" molded in three locations at the bottom of the piston.

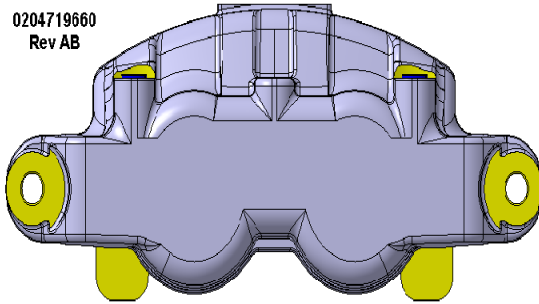
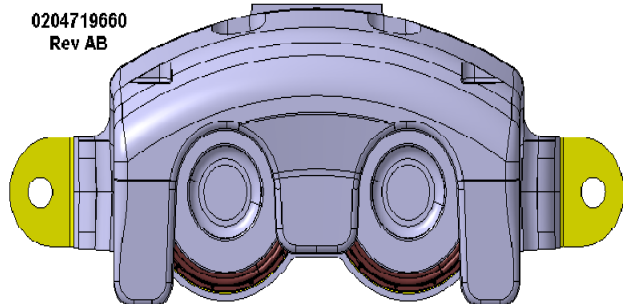
0204719660
Rev AB

Caliper machined areas shown in yellow are not plated.

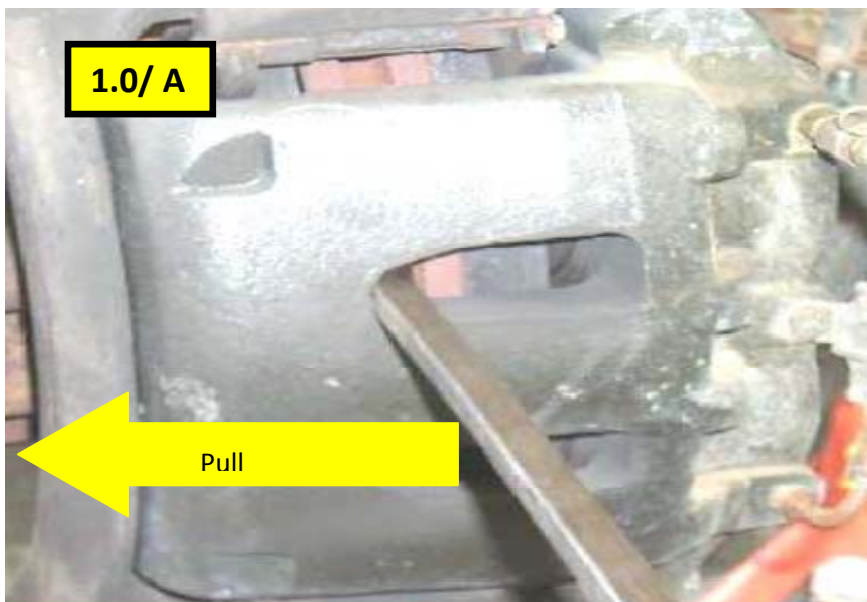
1. Remove two thirds of brake fluid from master cylinder.
2. Raise the vehicle, Refer to *Lifting and Jacking the Vehicle* in General Information in the service manual.
3. Support the vehicle with safety stands.
4. Mark relationship of the wheel to hub.
5. Remove the tire and wheel assembly, Refer to *Tire and Wheel Removal and Installation* in the service manual.
6. Compress caliper pistons using a disc brake caliper pad spreader, caliper dual piston compressor tool, c-clamp, pry bar, or other similar equipment. Compress until the pistons bottoms in the bore. (Shown in photo 1.0 / A)

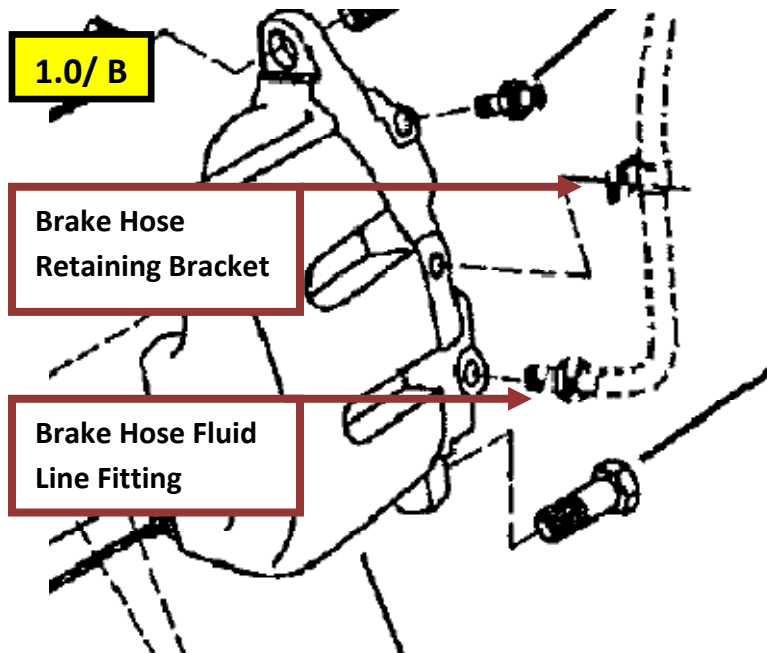
7. Remove the tool used to compress the caliper pistons.
8. Remove the brake hose retaining bracket fastener from the caliper. (View Illustration 1.0/ B)

9. Disconnect brake hose fluid line fitting from caliper and cap off to prevent brake fluid leakage or contamination in the line. Do not allow the brake line hose to become pinched or kinked during the remedy procedure. (View Illustration 1.0/ B)
10. Remove the upper (top) caliper mounting bolt securing the caliper to the upper guide pin. (Shown in Photo 1.0/ C)
11. Remove the lower (bottom) caliper mounting bolt securing the caliper to the lower guide pin.

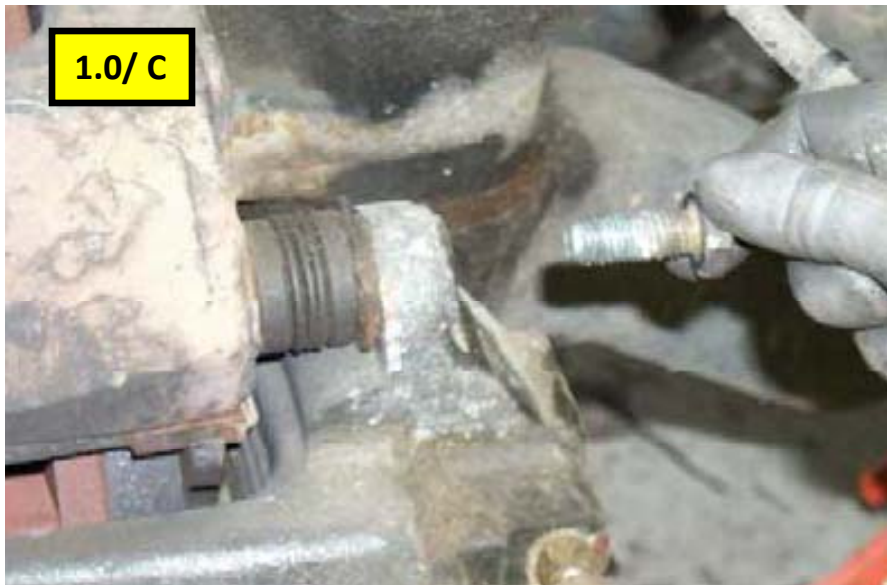
12. Move caliper assembly away from rotor.
13. Remove upper and lower caliper mounting pins and pin boots from anchor plate.

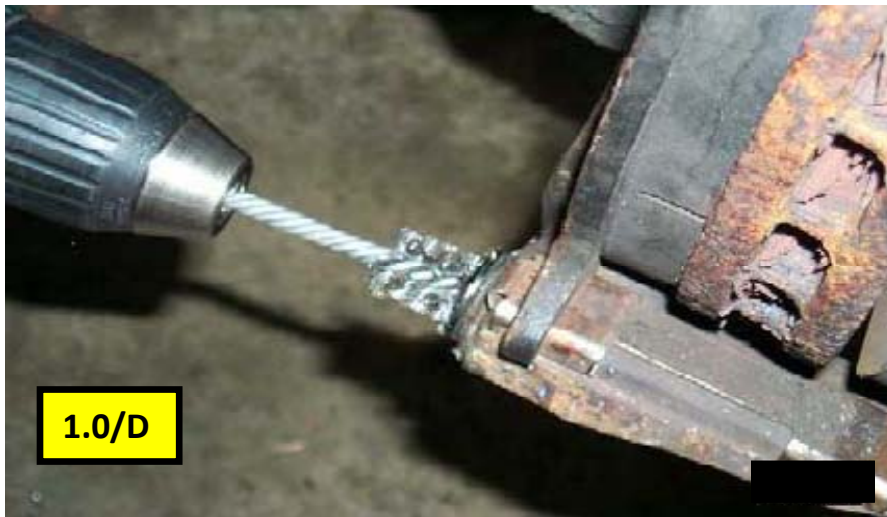
14. Clean the machined surface of the anchor plate with wire brush. (See photo 1.0/D)
15. Clean and lubricate the anchor plate bores with silicone brake grease.

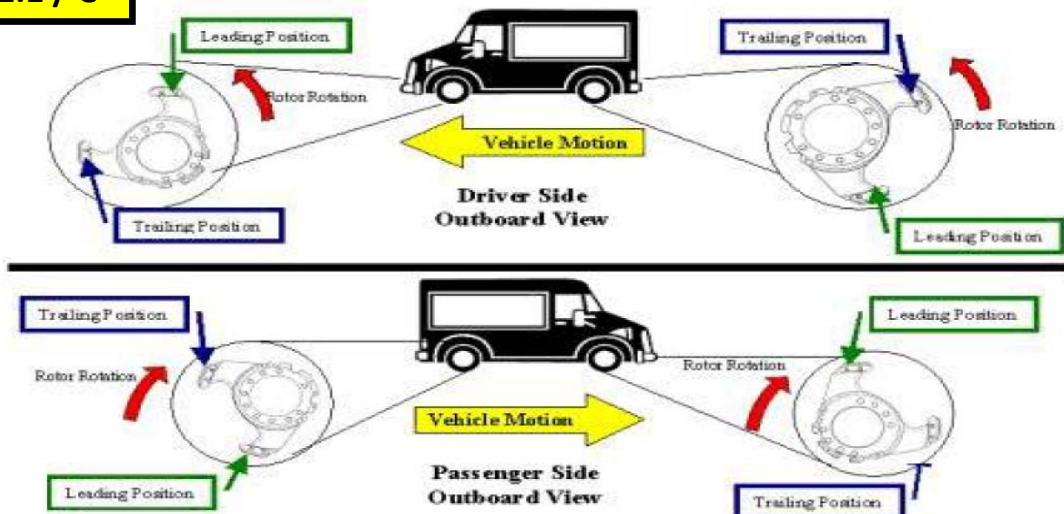
1.1 / C

IMPORTANT: The ZOH-T leading bolt must be tightened first during the assembly process after both leading and trailing bolts are installed finger tight.

Identifying Slide Pin Leading and Trailing Positions

6. Torque the ZOH-T mounting bolts as follows:
 - a. Torque leading bolt to 93-107 lb-ft (126-145 N-m)
 - b. Torque trailing bolt to 93-107 lb-ft (126-145 N-m)
 - c. See Leading and Trailing bolt position illustration (1.1 / C)
7. Connect the brake hose fitting to the fluid inlet port on the caliper and torque to 14-17 lb-ft (20-24 N-m). (See illustration 1.0 / B)
8. Reconnect the brake hose retaining bracket to the caliper using the original bolt removed. (See illustration 1.0 / B)
9. Bleed brake system torque bleeder screw to 8-15 lb-ft. (10-20 N-m)
10. Install the tire and wheel assembly and torque the wheel lug nuts to 450-500 lb-ft.
11. Lower the vehicle.

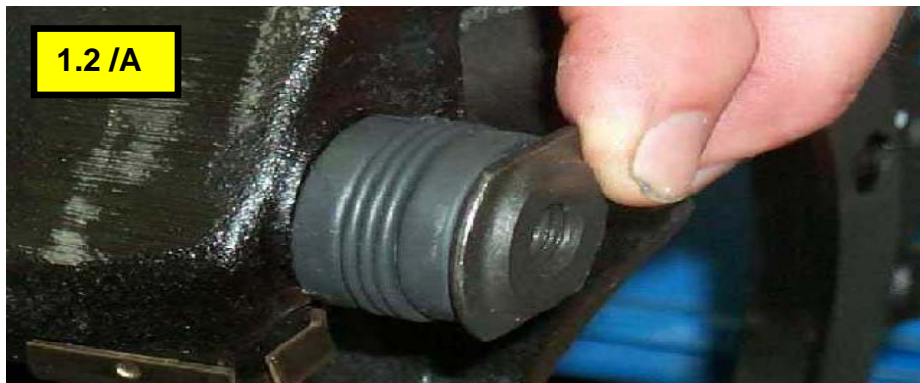
1. Inspect and lubricate the caliper slide pins with silicone brake grease.
2. When reusing the ZOH-T slide pin mounting bolt clean the threads and apply Loctite 2440 adhesive on bolt threads.
3. Align flat on upper (top) slide pin boss with the flat on the caliper housing upper (top) guide pin boss. Be careful when positioning caliper over disk brake pads, rotor and upper (top) guide pin to avoid tearing or dislodging piston boots or guide pin boots. (View Photo 1.2 / A)

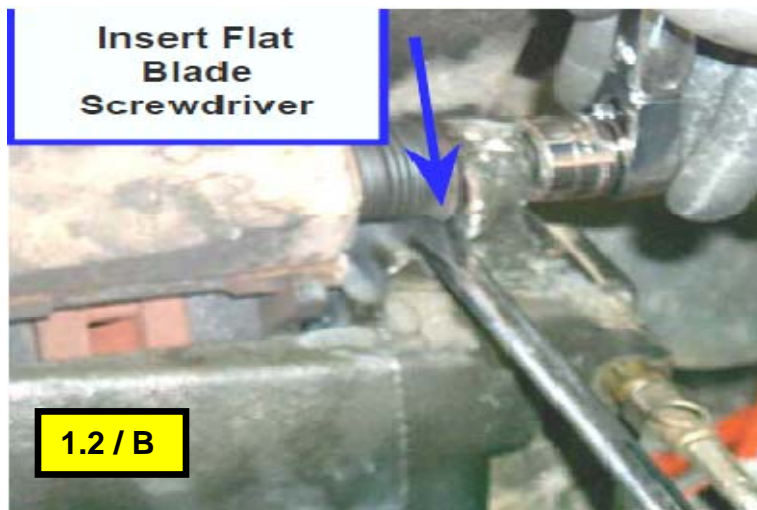
4. Install upper (top) mounting bolt "finger" tight.
5. Align the flat on the lower pin flange, and then carefully rotate the caliper closed and install lower mounting bolt "finger" tight. Utilize a flat blade screwdriver to retain the slide pin during the torque procedure. (Shown in photo 1.2 / B)

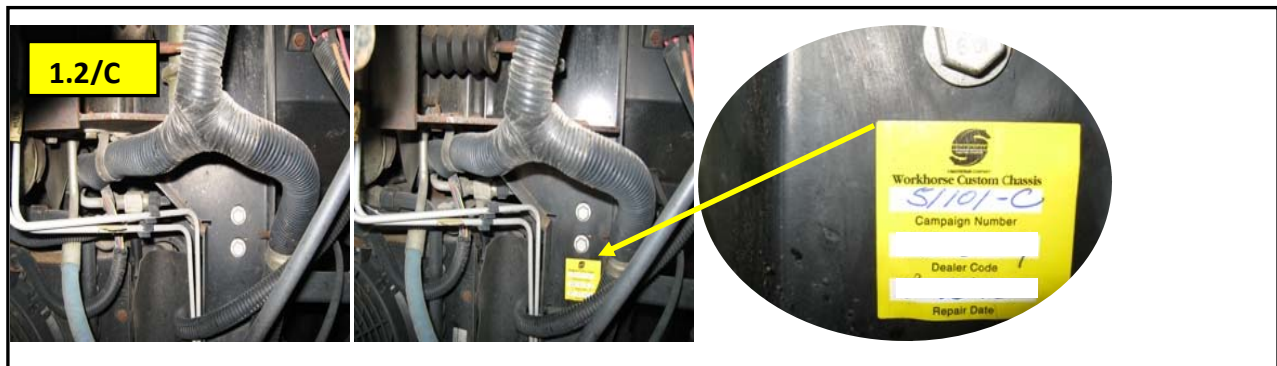
12. Complete the Recall Campaign Completion label and attach to the vehicle bulk head in a visible area near the chassis fuse box / Maxi Booster mounting bracket (Shown in photo 1.2/ C). One completion label (PN W8001493) will be shipped with every two caliper kits ordered.
